HISTORIC SITES SURVEY FIELD SHEET  
Individual Structure Survey Form

AA 596

Wallace, Davidson & Johnson Bldg.

LOCATION: 28 Market Space

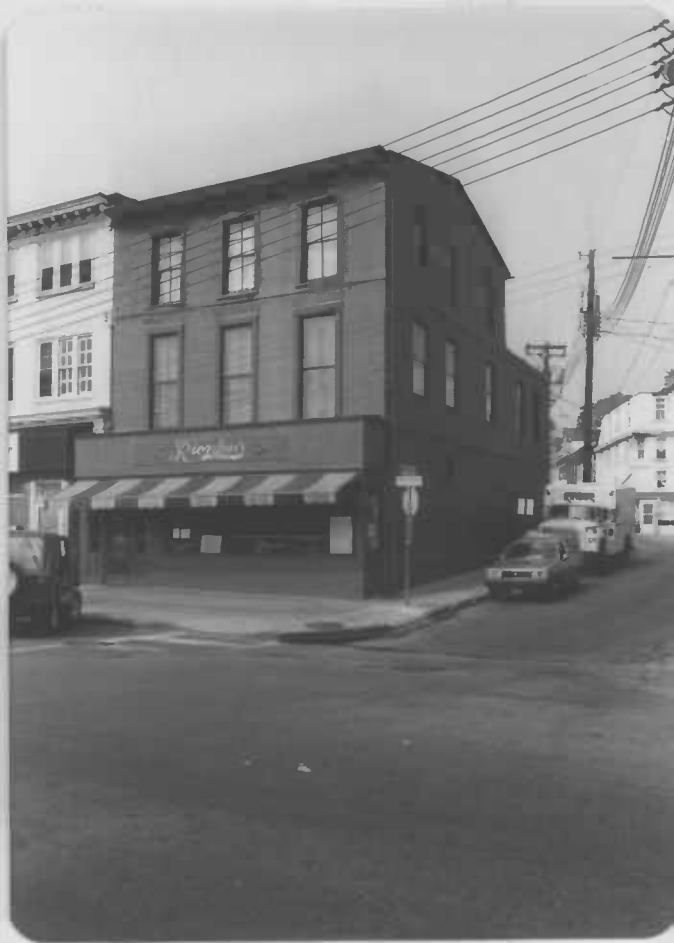
28 Market Space

Bracketed cornice, second and third floor windows with simple flat casings; belt courses at both upper floors; return at side elevation first floor altered.

NE Elevation/camera facing SW

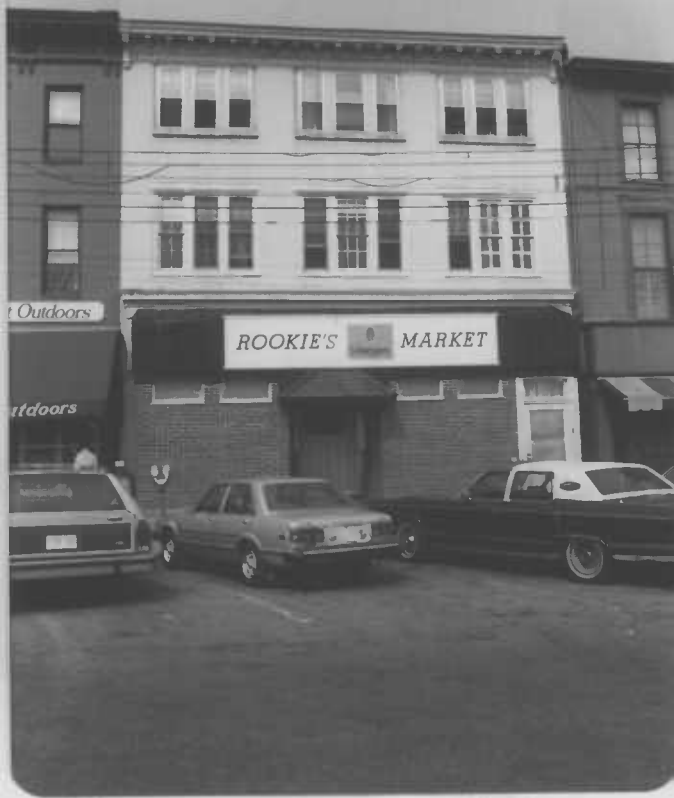
30 Mkt Space

Excellent bracketed cornice, triple windows at the second and third floor windows with molded caps; simple cornice at the first floor; first floor altered.

NE Elevation/camera facing SW

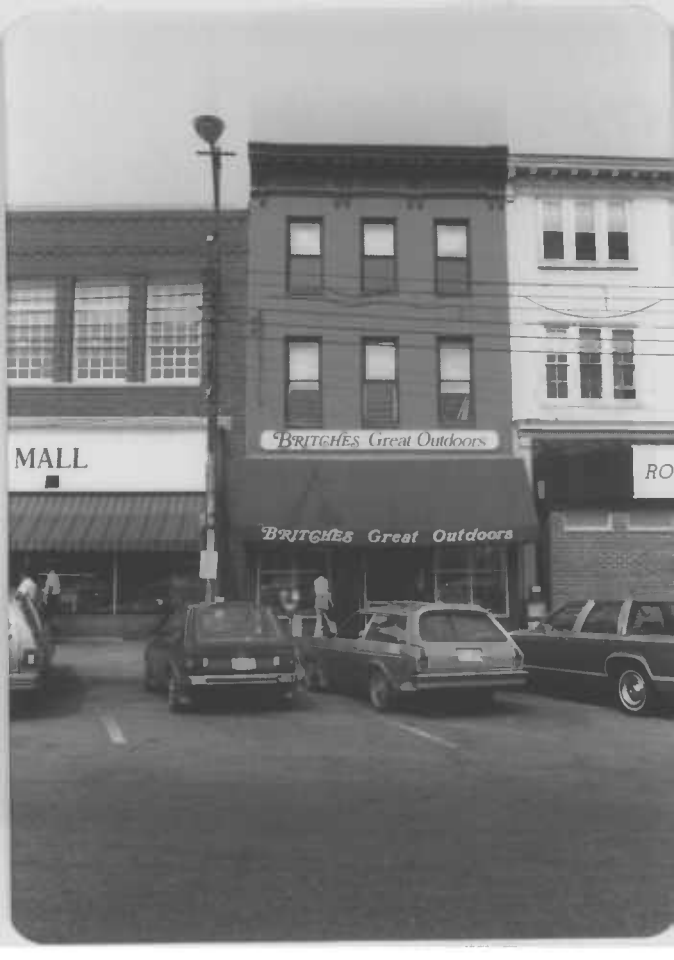
32-34 Market Space

Good bracketed cornice with paired consoles, molded frieze band and jig sawn panels; first floor altered.

NE Elevation/camera facing SW
